Purpose

MTU Onsite Energy is now offering a Low Coolant Level Switch that is compatible with both modern and existing system control logic. The following instruction describes replacing the existing switch with the new model on units in the field. Contact your MTU Onsite Energy Service Department at service-oed@mtu-online.com or +1 800 325 5450 if you have any questions or additional concerns related to this instruction.

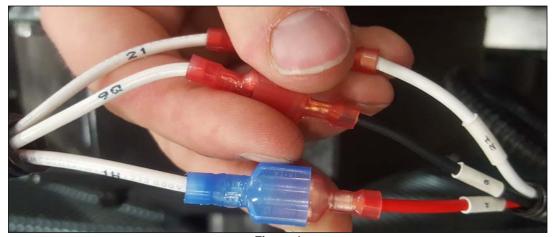
Figure 4

- 9. Wire the sensor to the generator.
 - o If using X00A69900004 or X00A69900002, simply plug the connector in until it clicks.
 - o If using X00A69900008, use the following instructions (See Figure 4):
 - Red (+) #1 wire attaches to white #1 wire on generator set.
 - White (Sig.) #21 wire attaches to white #21 wire on generator set.
 - Black () #9 wire attaches to white #9 wire on generator set.

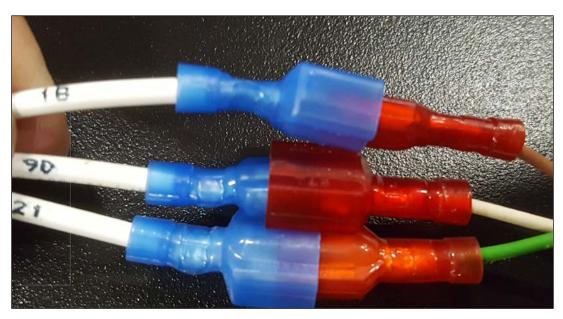
Figure 5

- o If using X00A69900003 or X00A69900005, use the following instructions (See Figure 5):
 - White (-) connects to wire #9
 - Green (Sig.) connects to wire #21
 - Brown (+) connects to wire #1
